Section D CONSTRUCTION AND CONDITION

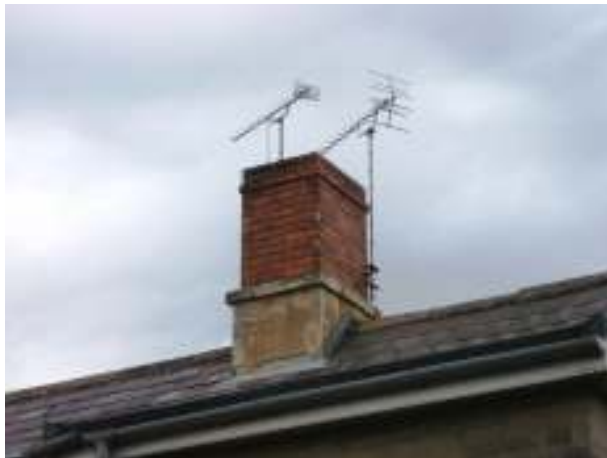
Rear view of chimney stack

There are no serious problems with the chimney stack. There is some slight weathering to the stone blocks, but no repairs are needed at the present time. There are lead flashings (water proof strips) fixed around the base of the chimney stack – these form a watertight seal between the masonry and the adjacent roof coverings. There is evidence of repair to the front left side of the flashings, but no signs of any ongoing problems.

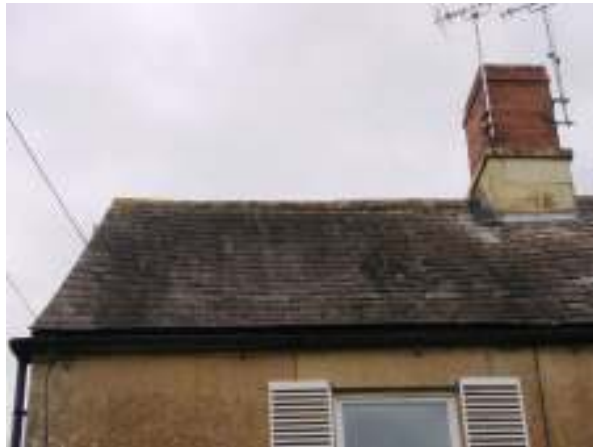
The front roof slope

Although there are no serious problems with the slates, the roof does undulate slightly (known as “dishing”). This is because of distortion of the supporting structure. It is not a serious problem and there are no signs of water penetration or other problems needing immediate repair. Because of the age of the coverings, you should expect to have to carry out occasional repairs, for example to replace slates that may slip after heavy storms, until such time as the coverings are replaced.

It is difficult to precisely predict the life expectancy of a slate roof, but usually a period of 60 to 80 years is considered the norm. As the coverings age, the frequency of repairs will increase. You should consider replacing the roof coverings within the next 5 to 10 years as this will not only remove the need for regular repairs, but also improve the appearance of the property and allow for improvements to insulation.

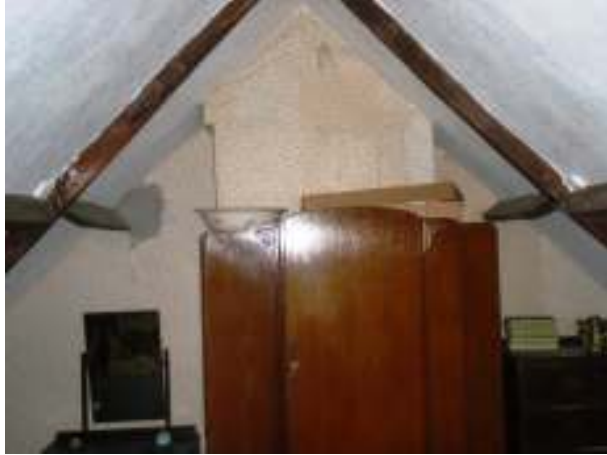
timber structure with horizontal timber purlins supporting sloping rafters which span from the ridge to the top of the front and rear walls. There are no obvious problems with the roof structure but, as noted above, there has been some distortion. It is common for roof timbers to deflect over time and this does not necessarily affect the structural integrity of the roof structure. You may find, when you do have the roof coverings replaced, that it will be necessary to replace some of the rafters, as these may have become damaged by water penetration or, possibly, wood boring insects. The condition of the rafters can only be confirmed once the coverings are removed.

Partially exposed roof structure in attic

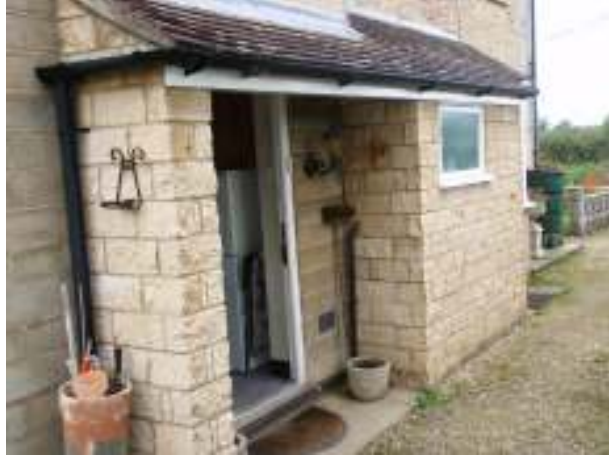
The sloping roof over the side extension is covered with concrete tiles. There are no signs of any problems with these.

Side extension

Where this roof adjoins the main wall of the building, lead flashings have been fitted and these appear effective.

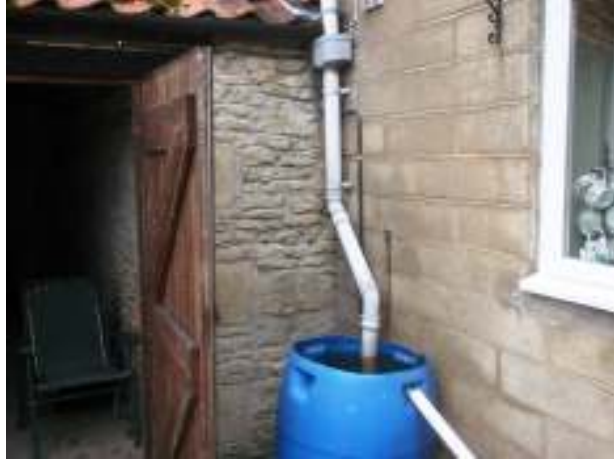
Two of the rainwater pipes are connected to plastic rainwater butts. The front butt is a proprietary model, but the rear as a re-used plastic drum with no cover. You should regard this as a temporary arrangement. Both have overflows fitted, to allow excess water to run back into the rainwater pipes.

Temporary rainwater butt

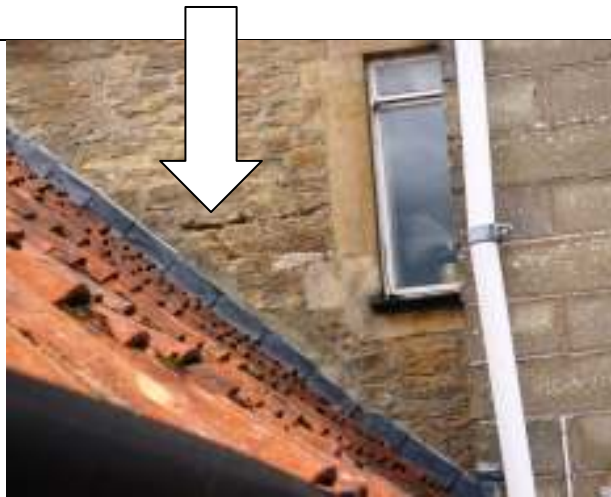
The original mortar pointing between the stone blocks on the left and rear elevations has been replaced at various times, but there is a very small area on the rear which does need some further minor repair. The position of this weathered mortar joint appears to correspond with the area of bulging plaster on the inside rear wall of the rear first floor bedroom (please see my further comments in section D11).

Weathered joint on rear wall

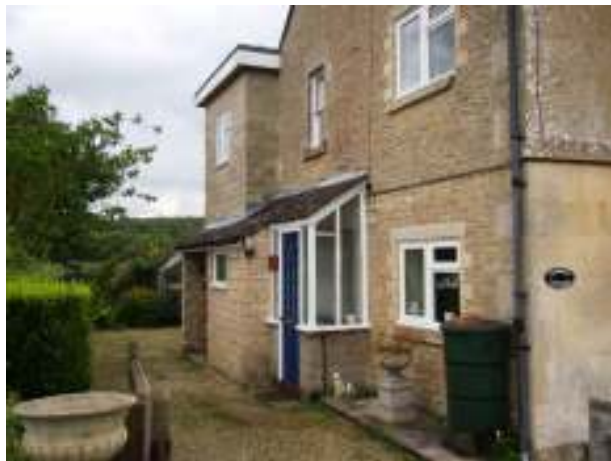
The original window openings have dressed stone lintels and surrounds. There are two modern openings on the left elevation. These have concrete lintels and reconstituted stone block surrounds. There are no problems resulting from these additions.

Left elevation
